# Old Glebe Water Main Break, November 23, 2009

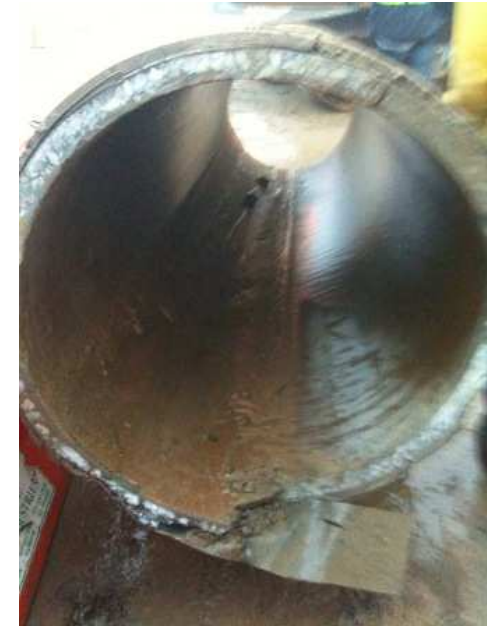
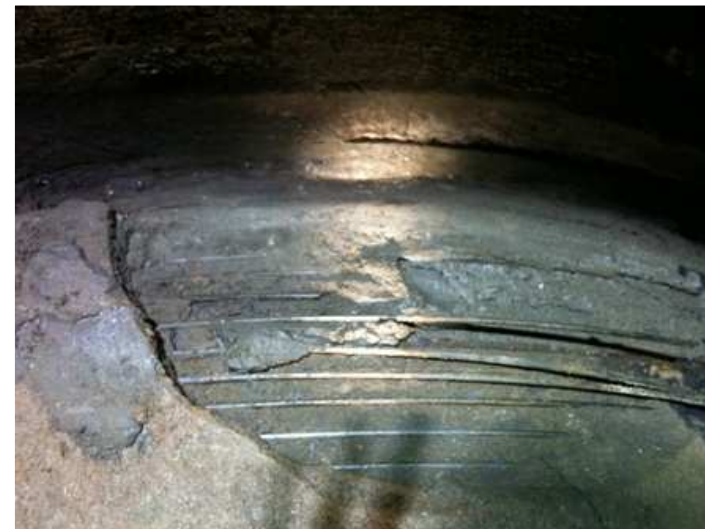
## Prestressed Concrete Cylinder Pipe (PCCP) –

Concrete pipe w/ steel liner, and reinforcing wires in the concrete outer shell. Installed in 1973 (36 years)

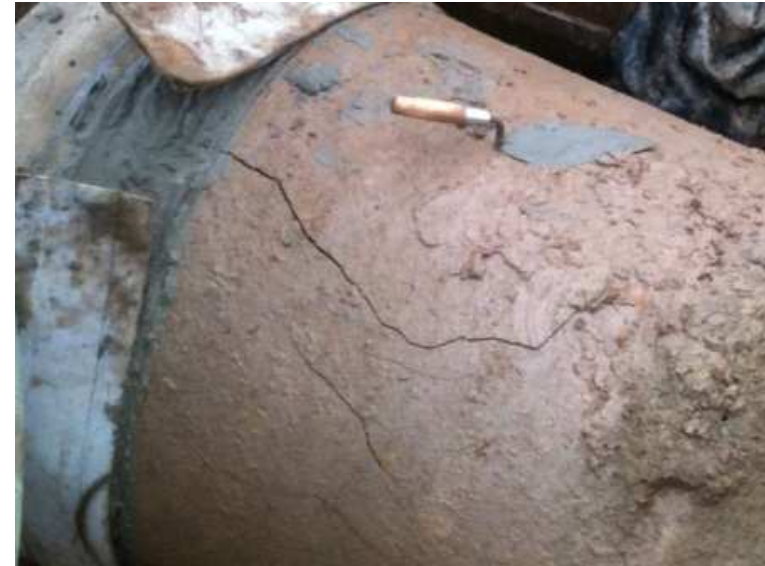
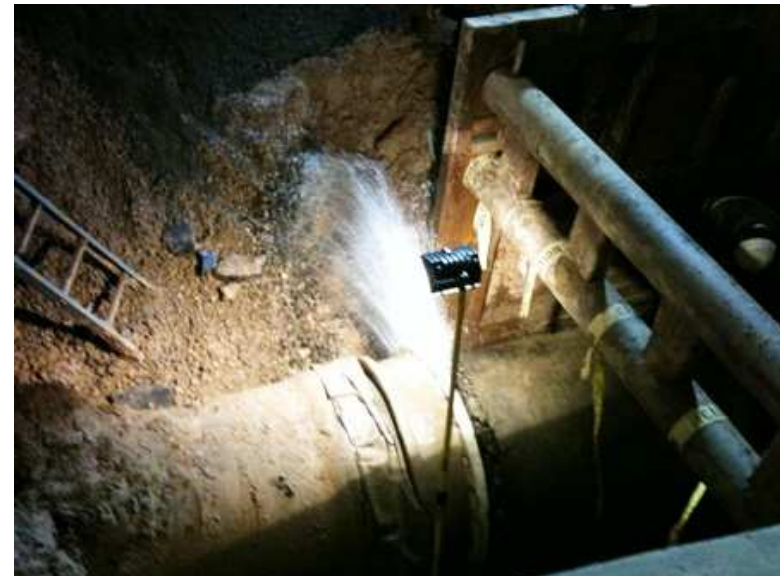
## Work Continues

- 16 foot section replaced and repaired
- More cracks discovered that need immediate repair
- Additional cracks a critical finding
- 6.5 feet of water in reservoir (PM)

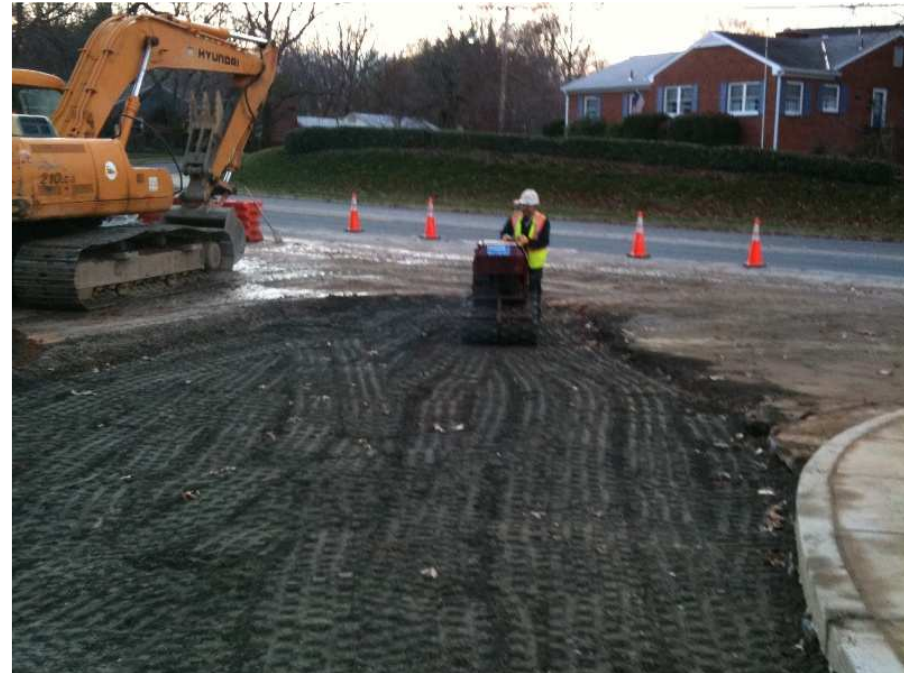
## Incident Closeout

- Friday (11/27) - backfill
- Monday (11/30) - open to traffic
- Thursday (12/3) - replaced damaged curb and sidewalk
- Spring 2010 - milling and paving of the entire block
